SUPPLIER VERIFICATION REPORT

Sample Demonstration Report

Report ID
VH-SAMPLE-2026-0164

Date
12 June 2026

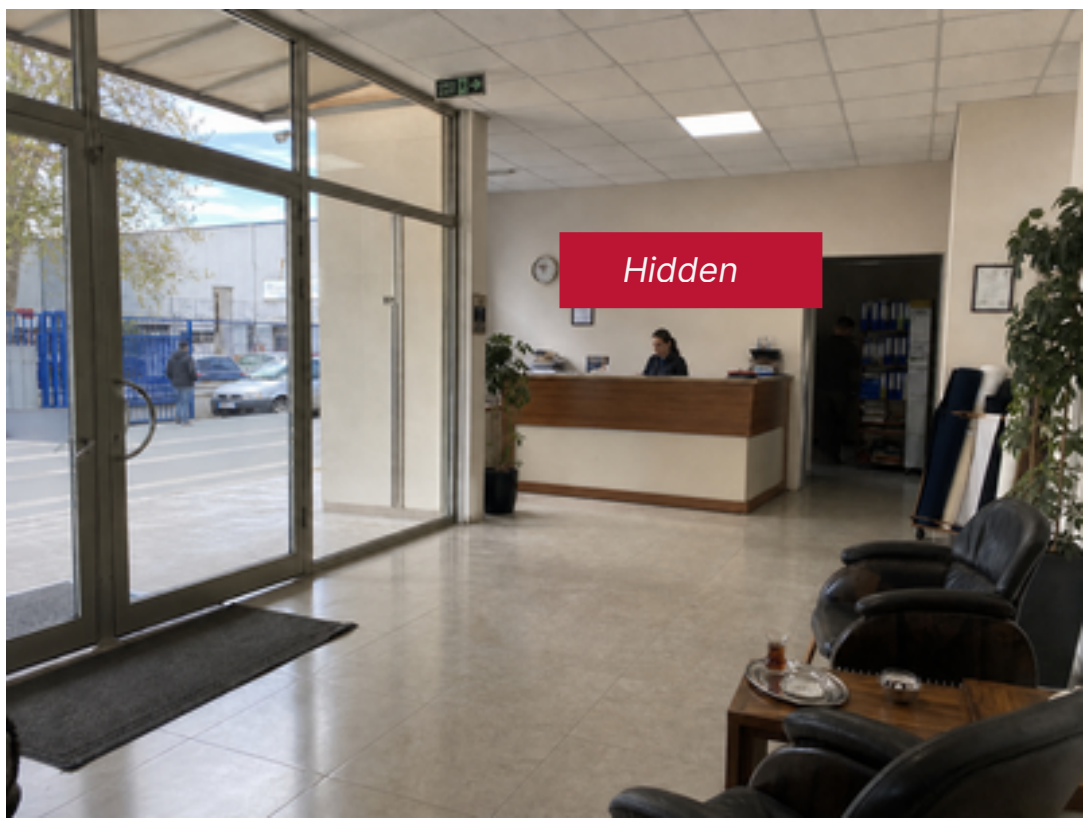
Finding	Result
Dedicated industrial facility visible	PASS
No mailbox-only or anonymous location signs	PASS
Controlled entrance / access point present	PASS
No severe abandonment or deterioration visible	PASS
Parking and surrounding activity observed	PASS
Exterior condition generally consistent with an active operating site	PASS

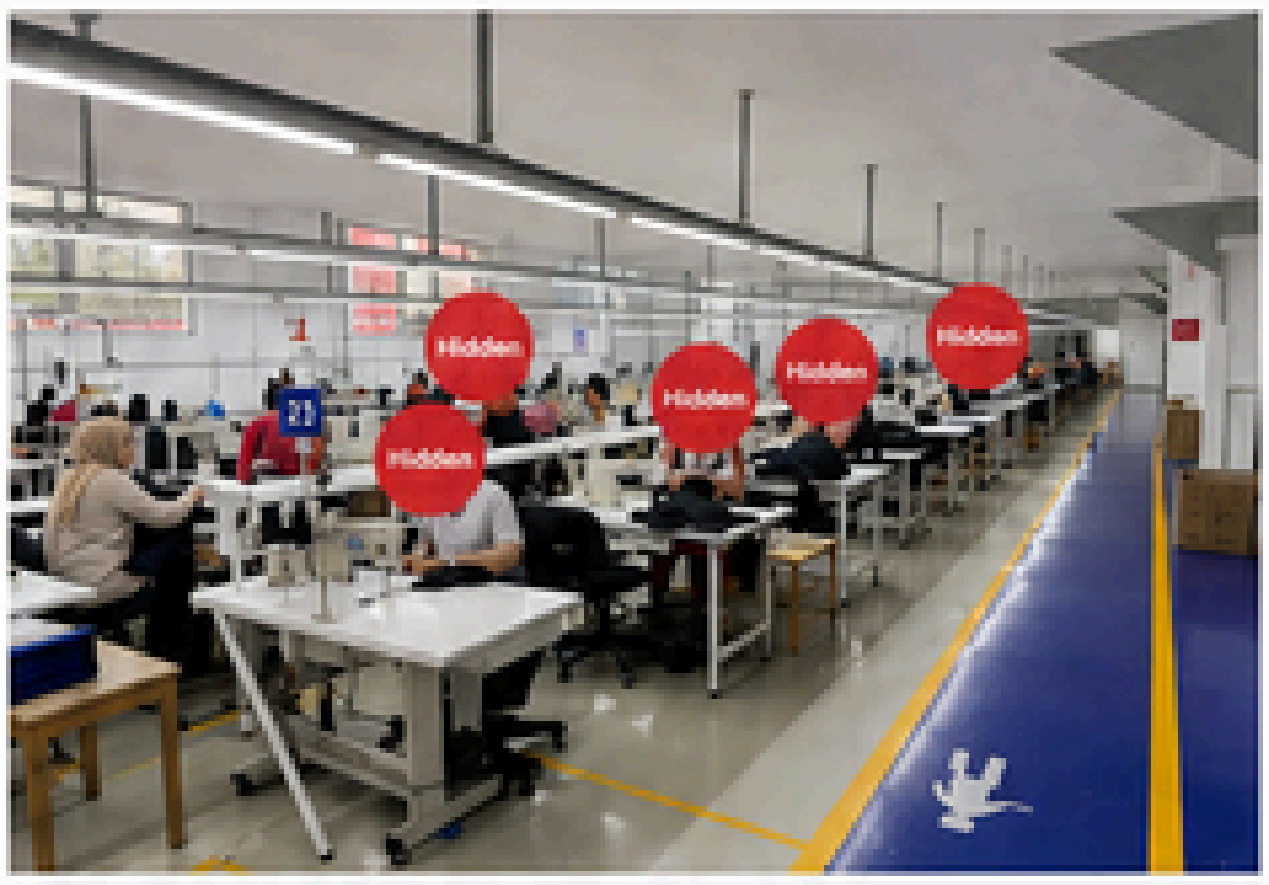
Photo 5: Production line – sewing operations
Multiple operators working at industrial sewing machines.

Photo 6: Production floor – active manufacturing
Active manufacturing operations with workforce at workstations.

Photo 7: Workforce activity – quality inspection
Employees conducting inspection and quality control activities.

Photo 8: Employee workstations – active operations
Industrial textile equipment in active use.
